DEPARTMENT OF TRANSPORTATION STATE OF GEORGIA

SR 120/Duluth Hwy @ Singleton Creek

Bridge Replacement

SUBJECT APPROVED REVISED CONCEPT REPORT

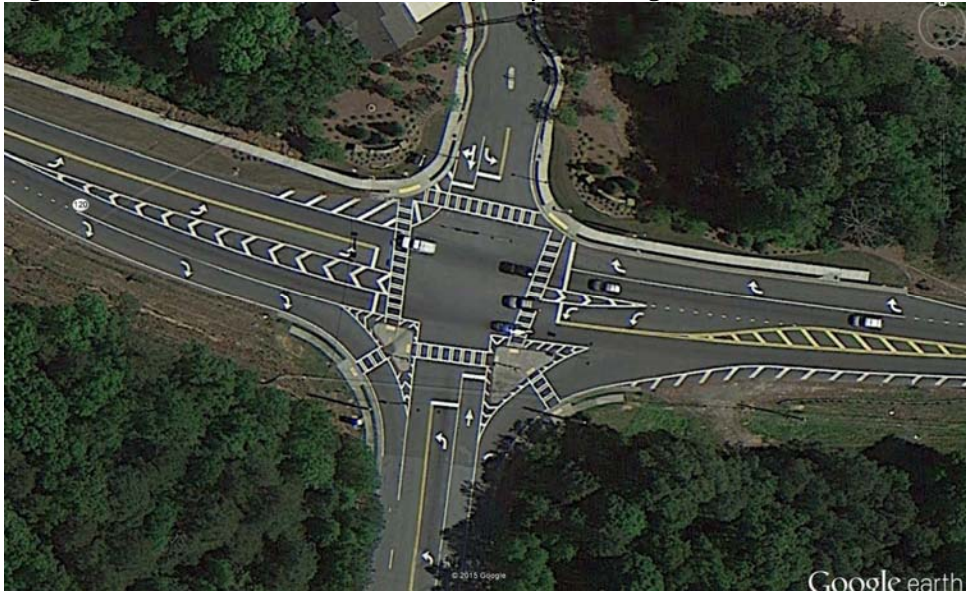
Figure 2: SR 120 at Northmont Parkway Existing Conditions

As a part of the project, intersection improvements are proposed for SR 120 at Northmont Parkway and SR 120 at Staunton Drive. The existing condition of each intersection is shown in Figure 2 and Figure 3.

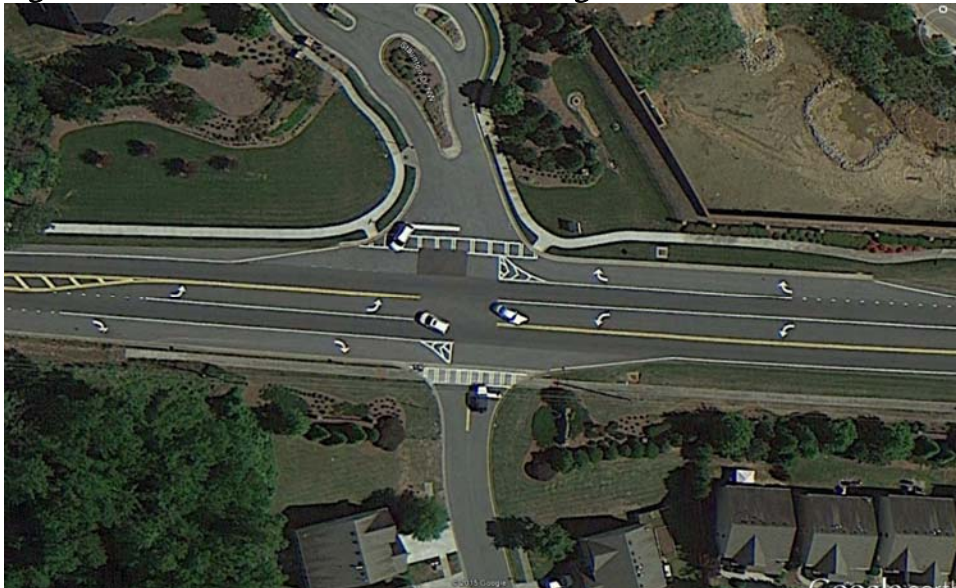
Figure 3: SR 120 at Staunton Drive Existing Conditions

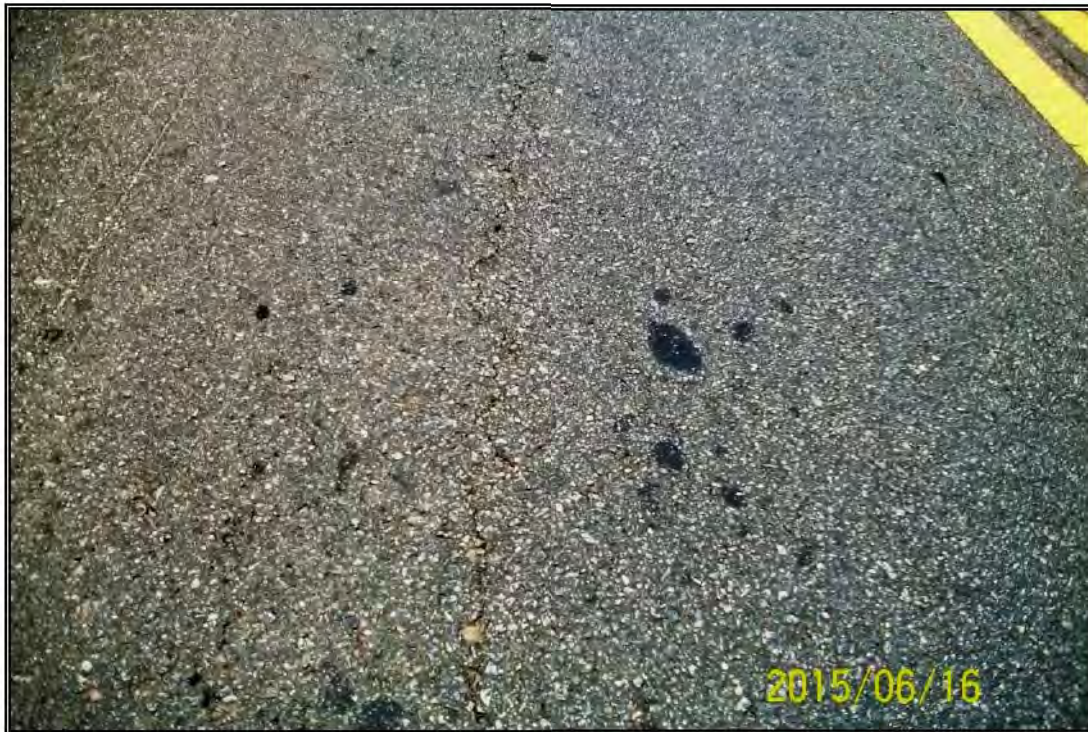
Load Distress – Severity Level 1 at Station 14+78, MP=4.95

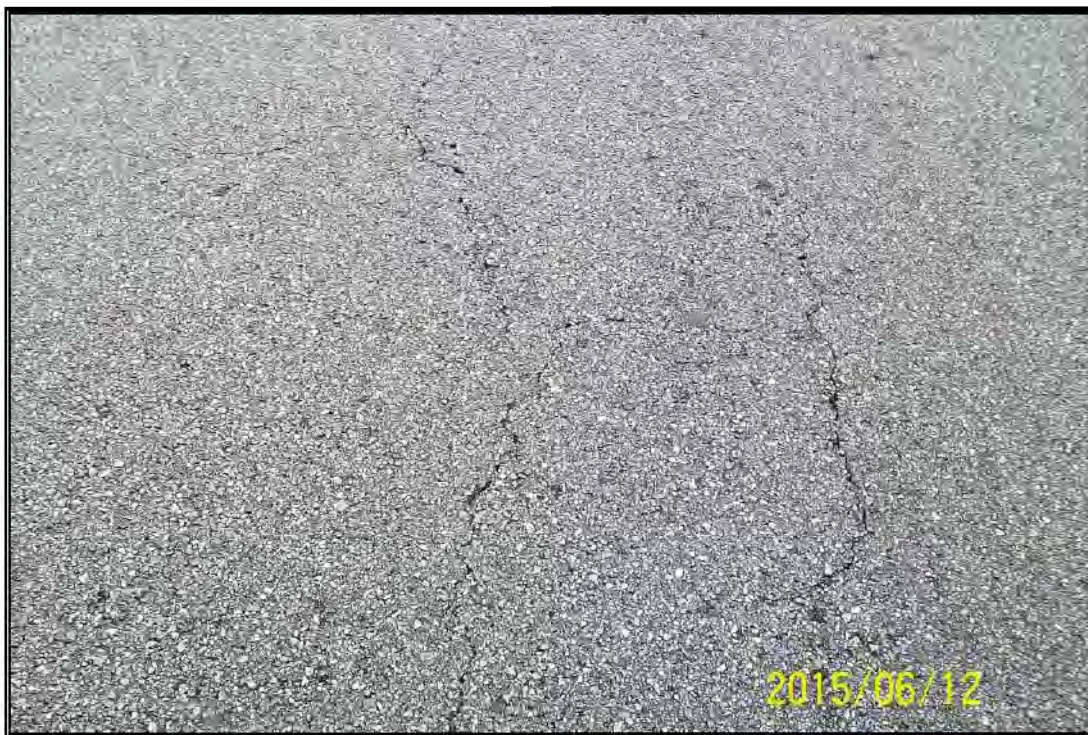
Load Distress – Severity Level 2 at Station 30+07, MP= 5.24

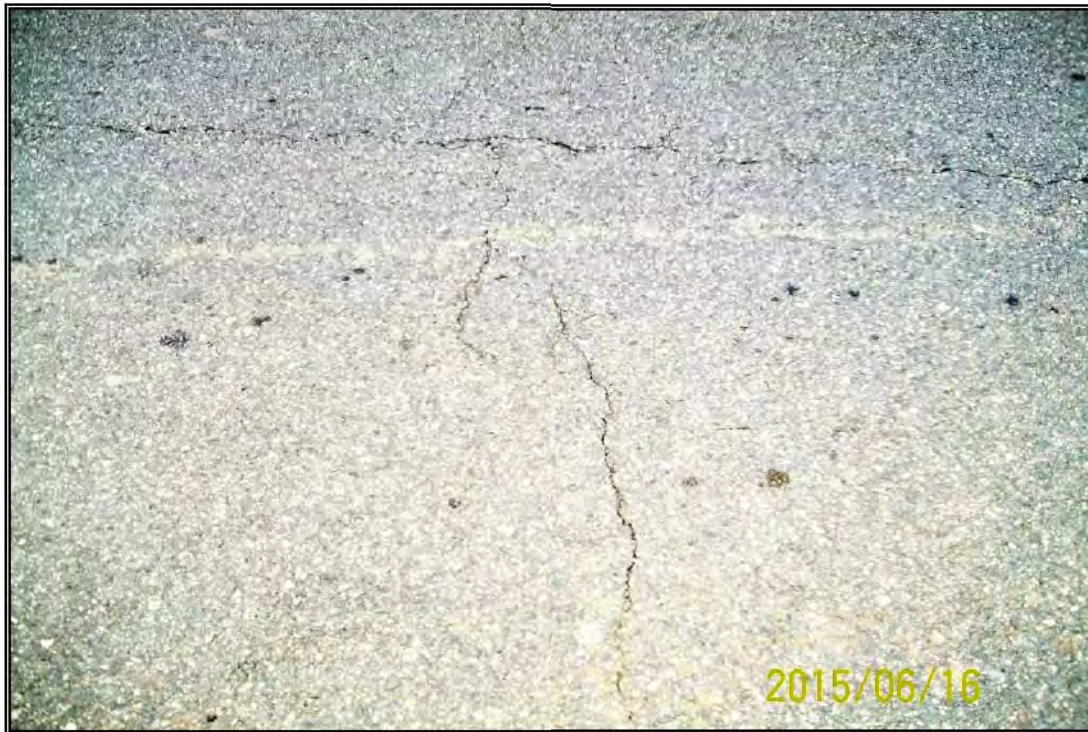
Block/ Transverse Distress – Severity Level 1 at Station 31+54, MP= 5.27

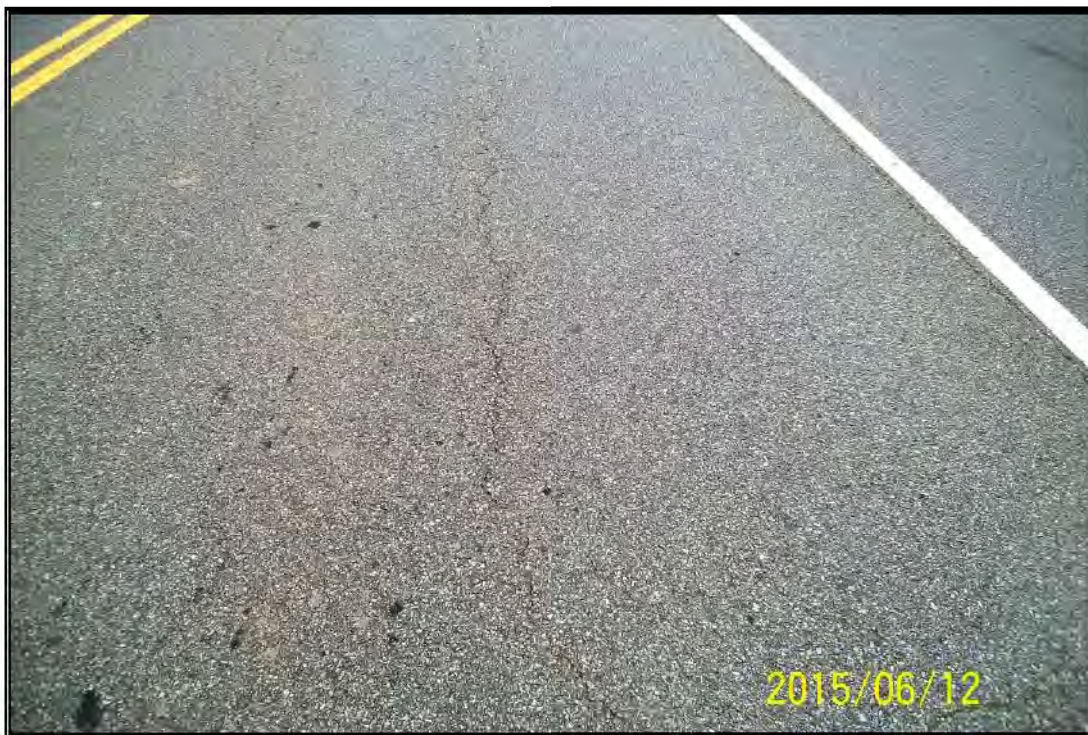
Block/ Transverse Distress – Severity Level 1 at Station 30+85, MP= 5.26

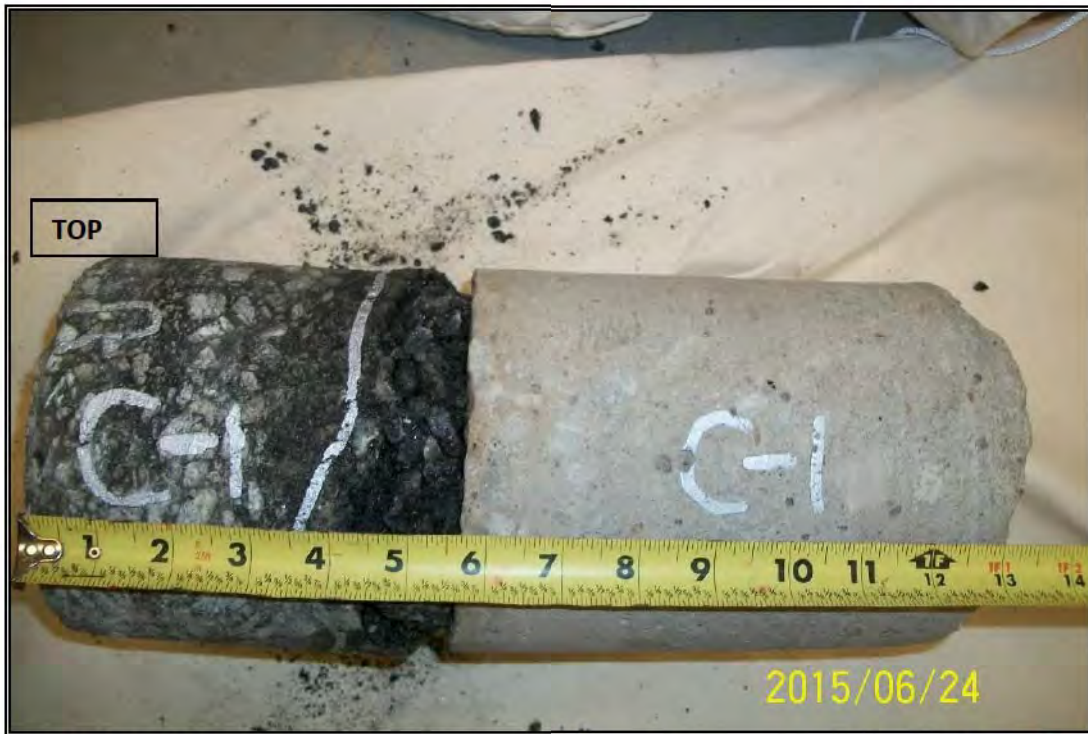
CORE C-1, SR 120, Sta. 14+41, Westbound, Lane 1, Passenger Wheel Path, MP= 4.95

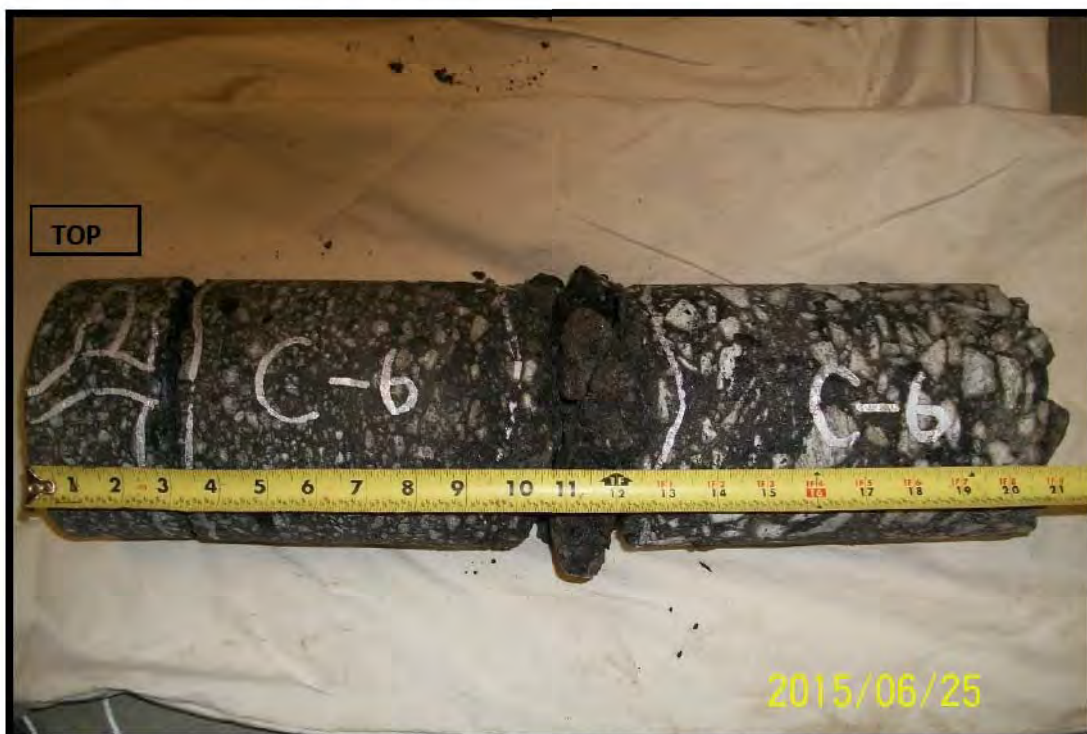
**CORE C-6, SR 120, Sta. 29+38, Westbound, Lane 1, Driver Wheel Path, MP= 5.23,
showing the other side of the core**

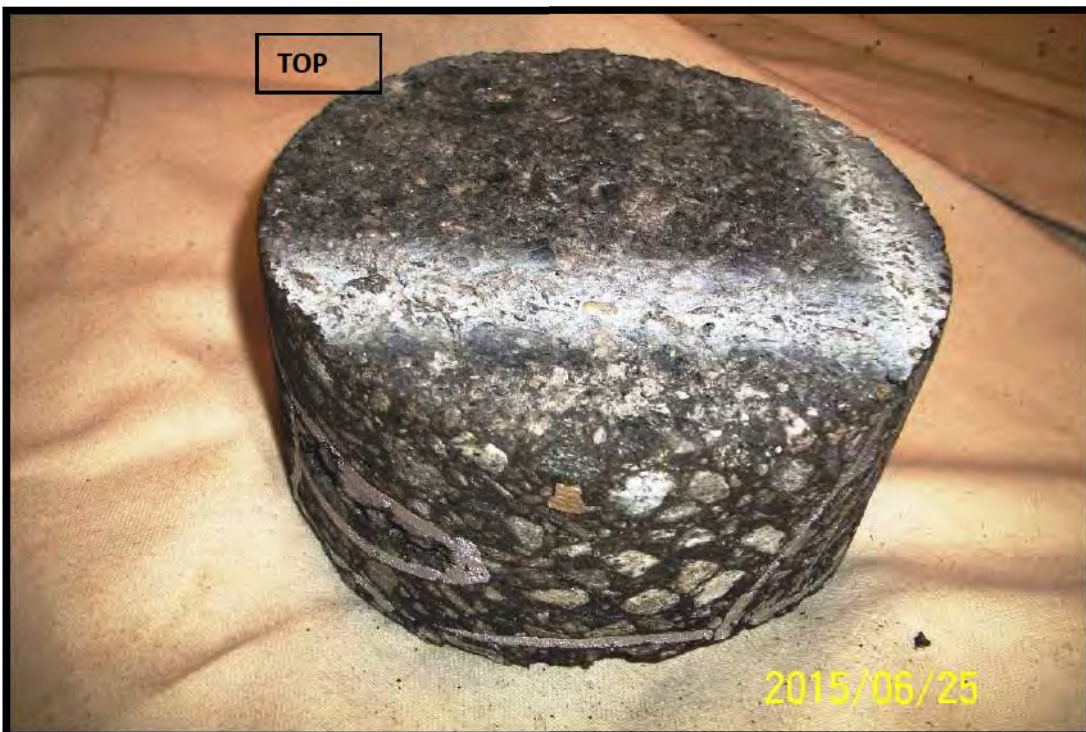
CORE C-6, SR 120, Sta. 29+38, Westbound, Lane 1, Driver Wheel Path, MP= 5.23, showing the top of the core
